## **REPORT ON INSPECTION OF UPPER YAPHANK LAKE DAM**

**NOVEMBER 30, 2007**

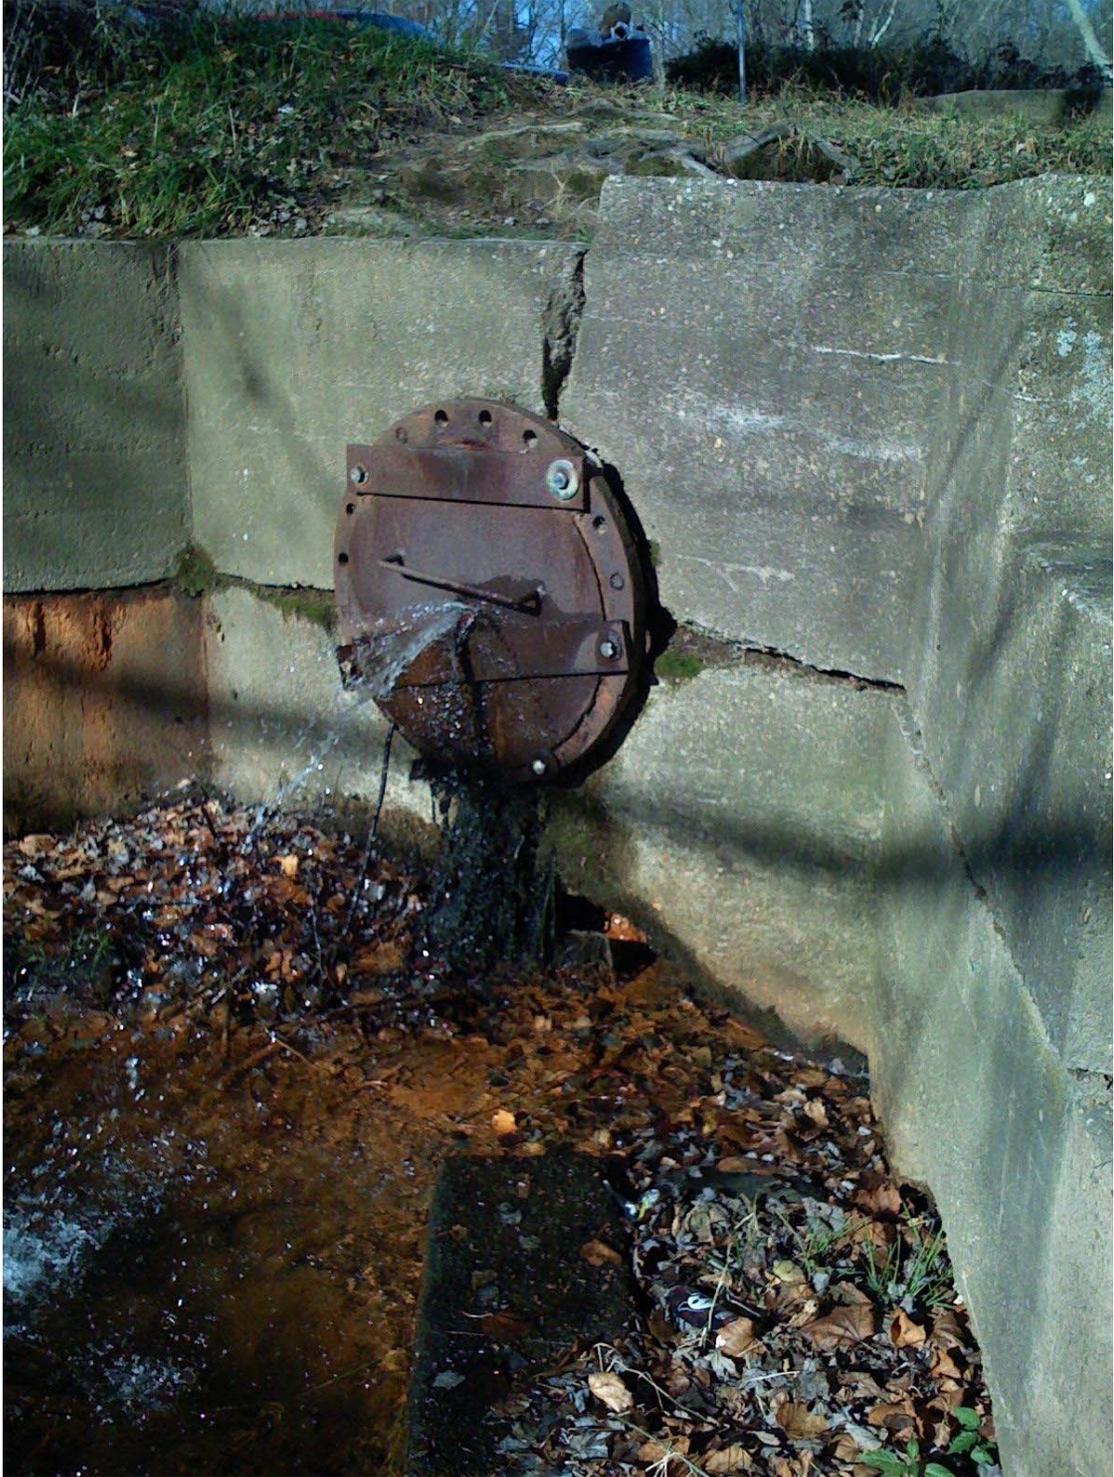
**PHOTO #1**

- 6) The existing bypass appears functional. The flange can be removed to bypass the spillway. The head wall for the bypass shows cracking but is stable (see photo 1).

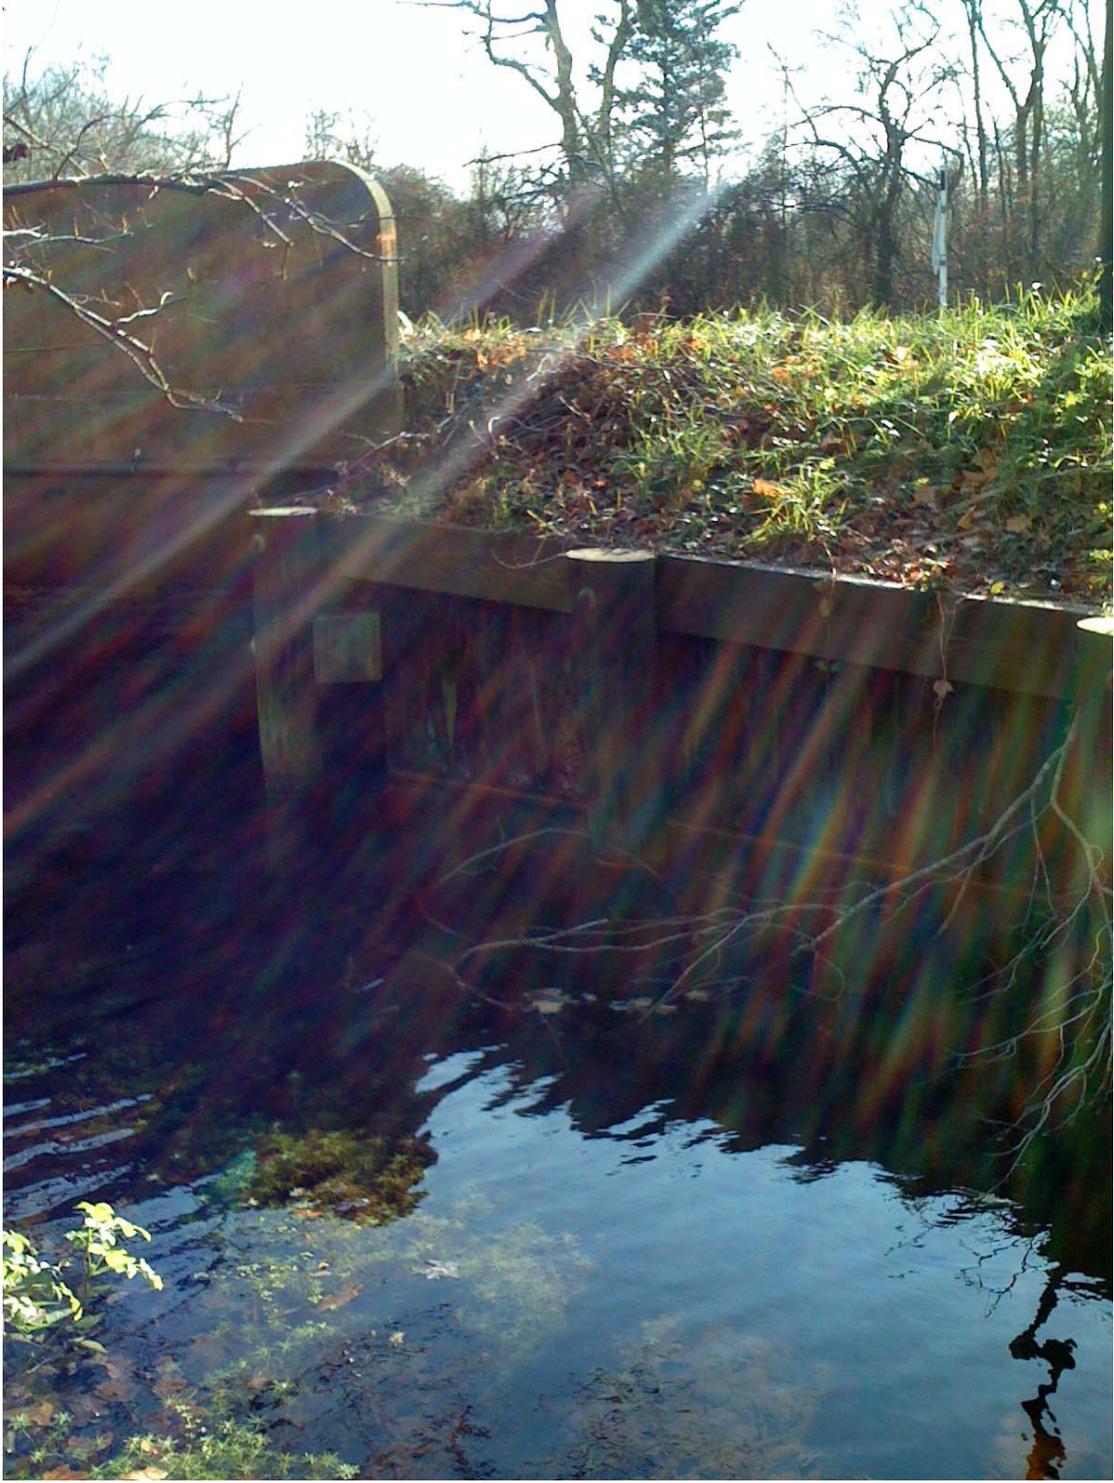
**PHOTO #4**

- 8) Bulkheading at the box culvert is in excellent condition and conservatively designed (see photos 4-5).

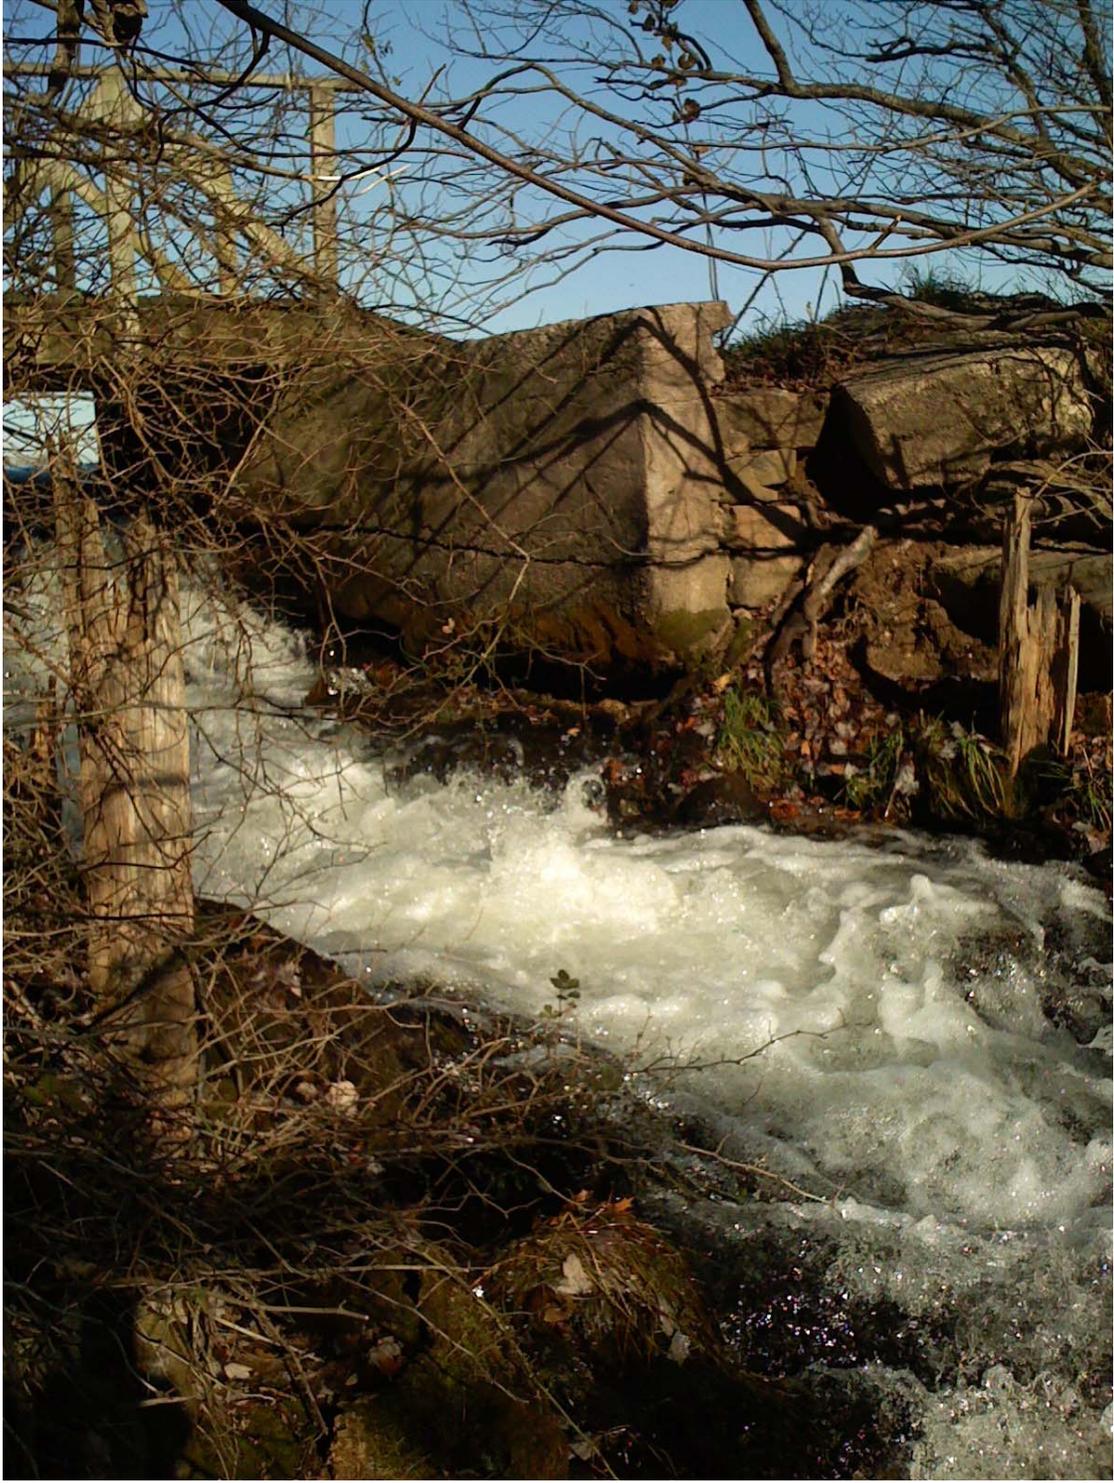
**PHOTO #6**

- 5) The east wall of the spillway is deteriorated with cracking and the wall leaning slightly inward (see photos 6-8). The wall is undermined at the bottom from water flow, although this area was not submerged during the inspection. This wall should be replaced by pouring a concrete wall adjacent to existing wall. The new wall should be constructed of reinforced concrete using the existing wall as a form on one side and tied back either into the existing wall or the soil behind the wall. The bottom of the wall can sit on the existing stone base in the spillway or a new foundation for the wall can be poured. The new wall would be about 5'H x 6"W x 15'L for a total of less than 1.5 yards of concrete. The cost of this is typically about \$5,000.

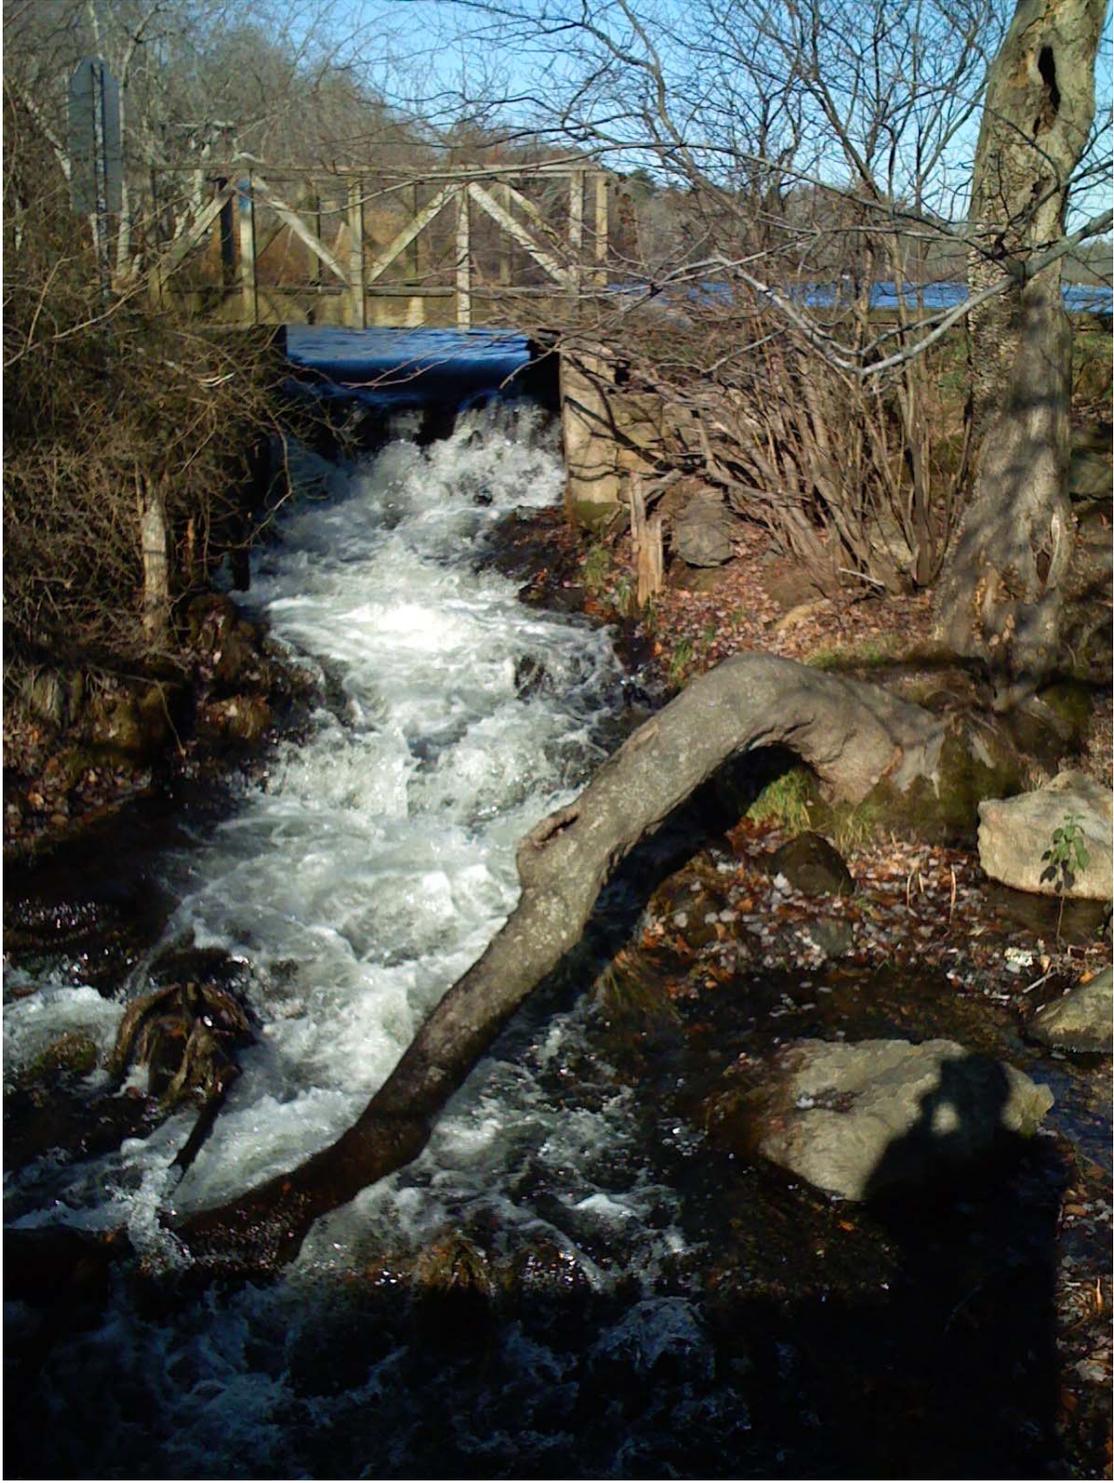
**PHOTO #9**

- 1) The dam consists of an earth fill dam with bulkheading on the upstream side impounding Upper Yaphank Lake (see photo 9). Generally, the bulkhead is in good condition and does not need replacement except for about four feet on the east side of the spillway. The dam is actually about two hundred feet wide with Yaphank-Middle Island Road running along the dam. A box culvert passes underneath Yaphank-Middle Island Road directing the overflow from the spillway southward towards Lower Yaphank Lake.

- 2) The concrete bulkhead on the lake west of the spillway is in good condition as is the west wall of the spill way (see photo 9).
- 3) The spillway consists of a notch in the concrete wall consisting of a concrete crest which appears in good condition. The spillway is approximately six feet wide and the notch is 25 inches deep. At the time of inspection the water level above the top of the crest was about 4-inches. We estimate the flow through the spillway to be between 3.75 and 4.6 cu.ft./sec.
