## **REPORT ON INSPECTION OF UPPER YAPHANK LAKE DAM**

**NOVEMBER 30, 2007**

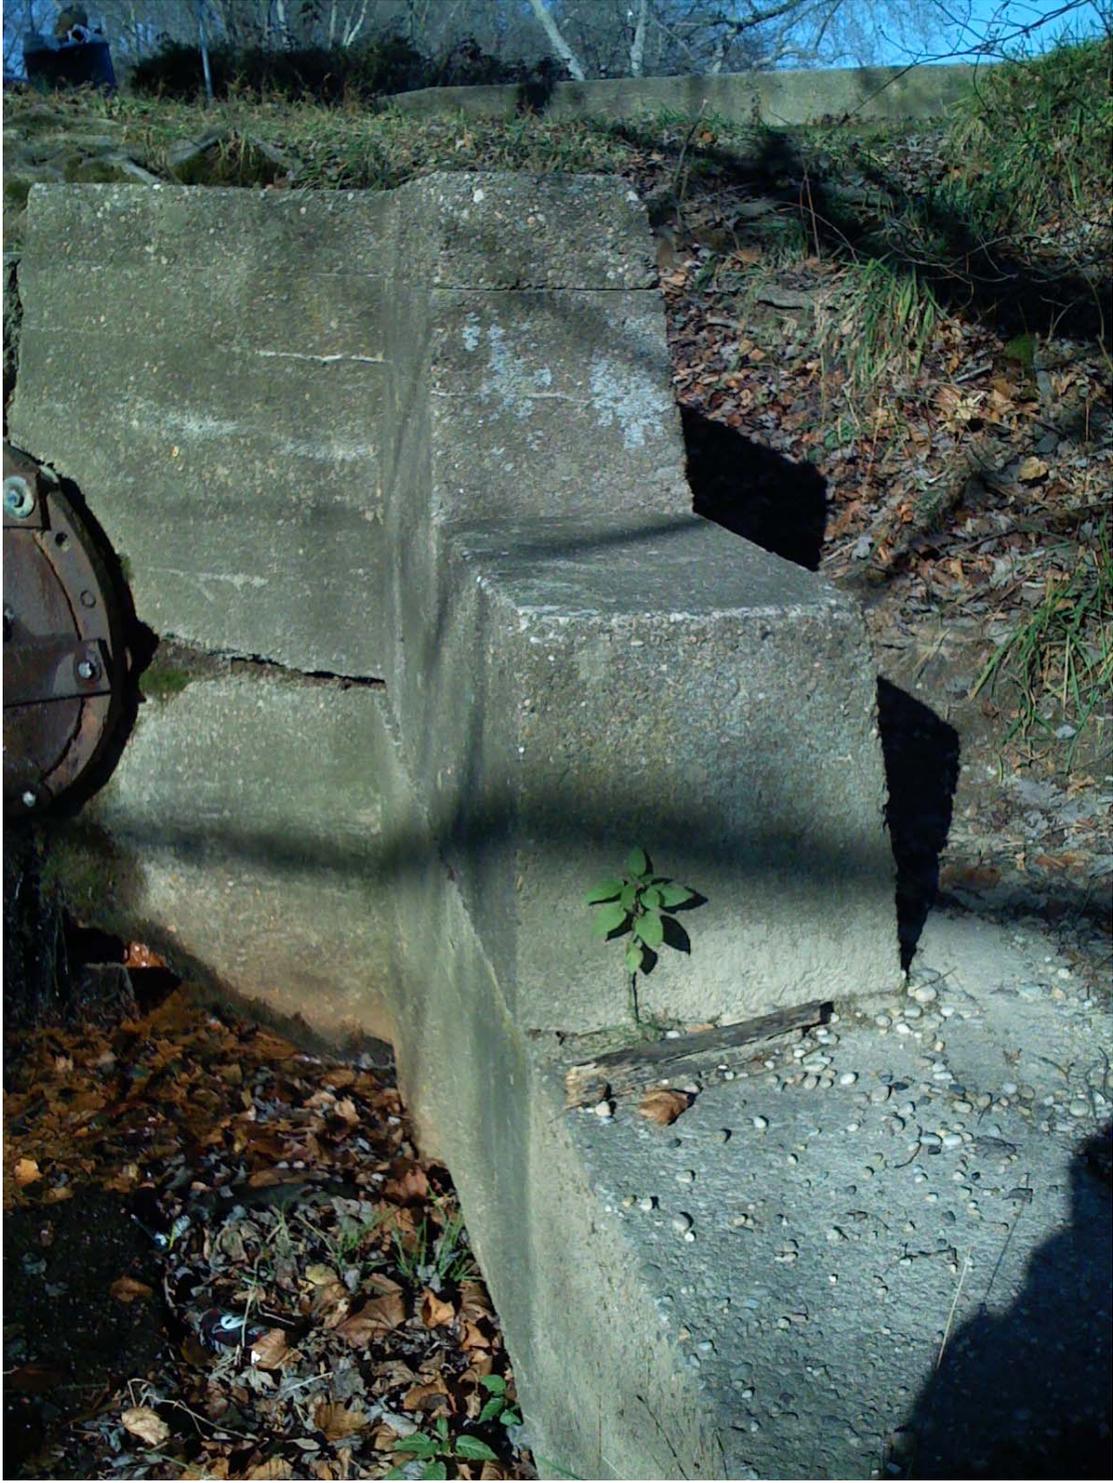
**PHOTO #1**

- 6) The existing bypass appears functional. The flange can be removed to bypass the spillway. The head wall for the bypass shows cracking but is stable (see photo 1).

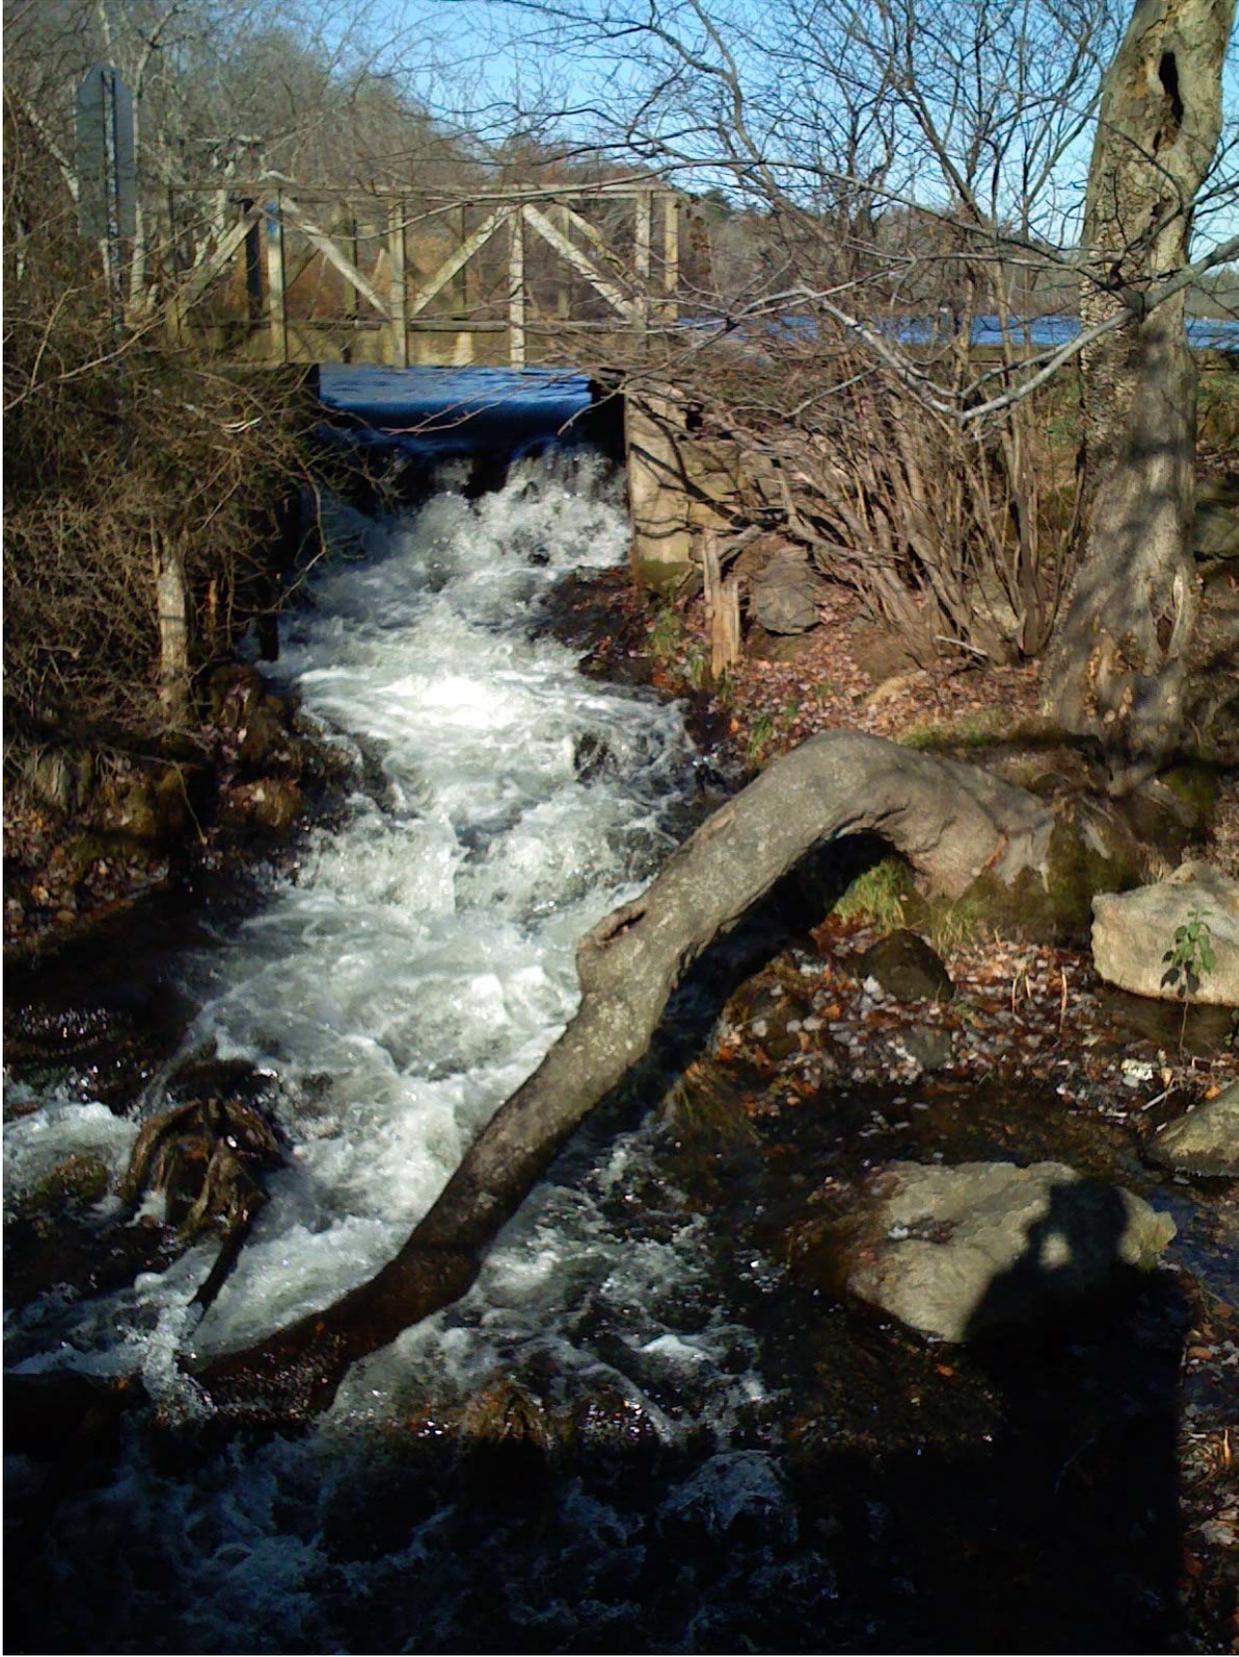
**PHOTO #9**

- 1) The dam consists of an earth fill dam with bulkheading on the upstream side impounding Upper Yaphank Lake (see photo 9). Generally, the bulkhead is in good condition and does not need replacement except for about four feet on the east side of the spillway. The dam is actually about two hundred feet wide with Yaphank-Middle Island Road running along the dam. A box culvert passes underneath Yaphank-Middle Island Road directing the overflow from the spillway southward towards Lower Yaphank Lake.

- 2) The concrete bulkhead on the lake west of the spillway is in good condition as is the west wall of the spill way (see photo 9).
- 3) The spillway consists of a notch in the concrete wall consisting of a concrete crest which appears in good condition. The spillway is approximately six feet wide and the notch is 25 inches deep. At the time of inspection the water level above the top of the crest was about 4-inches. We estimate the flow through the spillway to be between 3.75 and 4.6 cu.ft./sec.
